HONEY CREEK, TENN.
N3622.5-W8437.5/7.5
1952

LANDSLIDES AND RELATED FEATURES

OF THE HONEY CREEK, TENN. QUADRANGLE

U.S. Geological Survey
OPEN FILE MAP 82-653 (D-11)

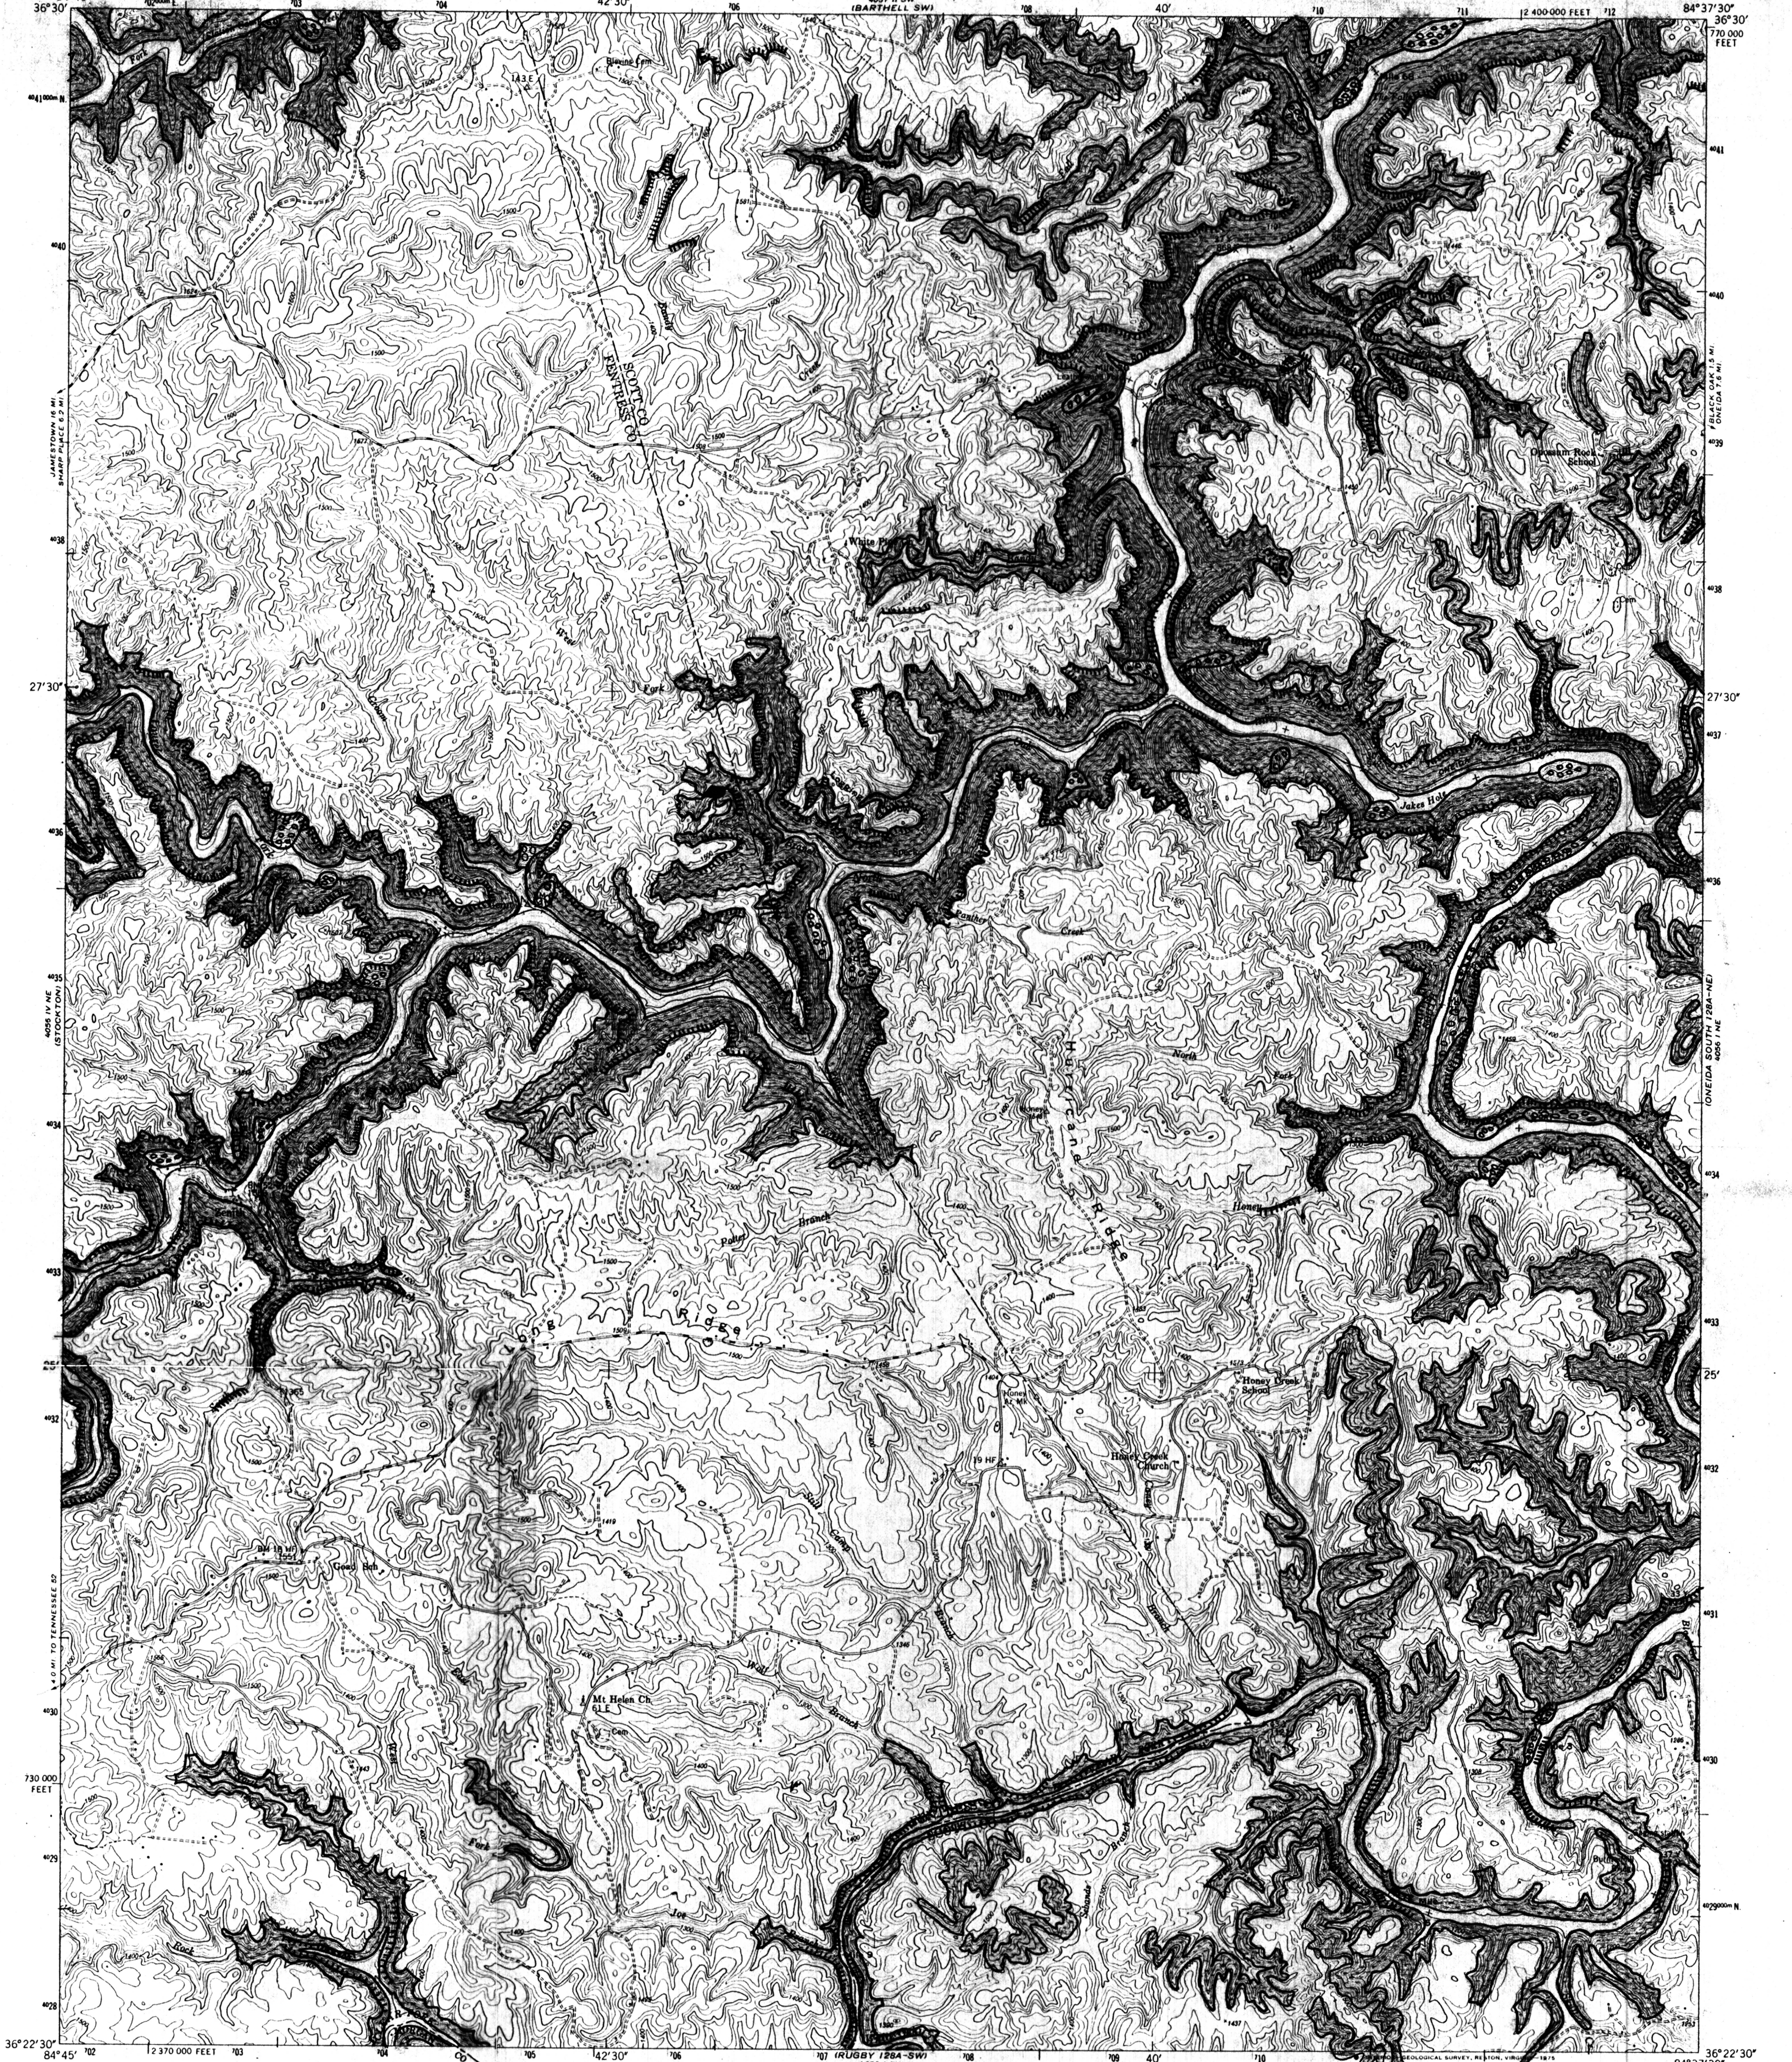
Landslides and related features interpreted
from aerial photographs:

**ACTIVE OR RECENTLY ACTIVE LANDSLIDE**
Complex landslide composed of earthflow, debris
slide, earth and rock slump. Identified from
historical records, and from scars, debris and
other field evidence. Ground extremely unstable;
sliding accelerated by excavation, loading and
changes in drainage conditions. May include
areas with several active slides too small to
be shown separately. Questioned where doubtful.

**OLD LANDSLIDE**
Area of extensive hummocky ground caused by
earthflow and earth and rock slump. Lacks
clear evidence of active sliding. Relatively
stable in natural, undisturbed state,
generally not affected by small structures properly
sited in areas away from the edge of the toe;
can be reactivated by extensive, rapid exca-
vation, loading, and changes in ground water
and surface water conditions. Area of old landslide
probably includes recent ones not identified
from field evidence or otherwise documented.
Upslope boundary of landslide generally defined
by modified scarp, but downslope (toe) may be
gradational and not well defined. Questioned
where doubtful.

**COMBINATION LANDSLIDE**
Area of recent and old slides in which
individual slides are not identified.

**COLLUVIAL SLOPE**
Valley wall along major streams with slope as
steep as 40° (85%); stony, clayey silt soil up
to 50 ft. (15 m) thick; commonly buttressed by
a terrace or bench at the toe of the slope; very
susceptible to sliding by cutting of toe area,
removal of terrace or bench, and overloading;
slide commonly activated without apparent cause.

**COLLUVIAL SLOPES WITH LANDSLIDES**
Landslides too small or obscure to map
individually.

**AREAS SUSCEPTIBLE TO DEBRIS FLOWS AND DEBRIS
AVALANCHES**
Primarily shallow, narrow ravines and chutes with
accumulation of stony colluvium generally 10 ft.
(3 m) or less in thickness; susceptible to rapid
movement during intense rainfall. Most ravines
and chutes designated show evidence of former
debris flows and avalanches.

**AREAS SUSCEPTIBLE TO ROCKFALL**
Steep, locally vertical, natural and man-made
slopes and cliffs, 15 ft. (4.5 m) or more high;
formed dominantly of sandstone, limestone, sandy
shale, mudstone and claystone. Interbedded mud-
stone, claystone and shale weather rapidly leaving
sandstone and limestone rock faces unsupported.

**SOIL AND ROCK SUSCEPTIBLE TO LANDSLIDING**
Soil and rock similar to that involved in land-
slides elsewhere in map area; primarily areas
underlain by claystone, mudstone and shale
associated with other rock types. Rock weathers
rapidly on exposure forming clayey soil highly
susceptible to sliding. Includes coves (U-shaped,
shallow valleys) containing thick layers of clayey
soil that are very susceptible to sliding where
excavation breaks continuity of slope and where
overloaded by artificial fill.

AREAS LEAST PRONE TO LANDSLIDES
Map areas in which no patterns or symbols are shown;
primarily valley floors, ridge tops and broad
benches; modification by excavation and fill may
lead to local landslides.
